Why was the HP StorageWorks XP12000 Disk Array able to take the bullet and keep running? white paper

Executive summary

This white paper describes the features of the HP StorageWorks XP12000 Disk Array that enabled it to be shot and keep operating. National Technical System (NTS) administered the “bulletproof” test at its ballistics testing facility in Arkansas. The video of the shooting event is available at www.hp.com/go/storageworks/bulletproofxp. It is strongly recommended that the reader view both the video clip and the documentary.

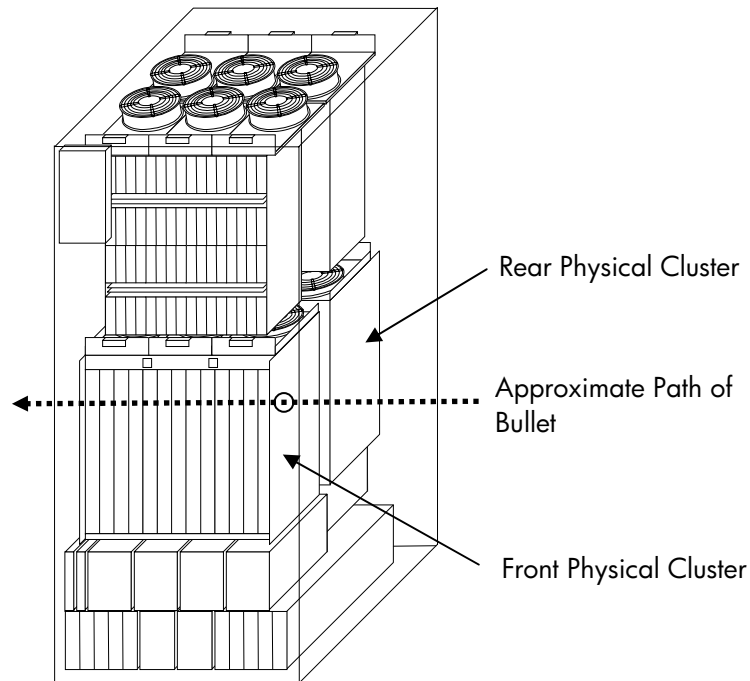
XP12000 Center Cabinet

The XP12000 Disk Array has physically redundant hardware components that are located in separate areas in the array. The redundant circuit cards are located in front and back pairs when the array is viewed from the side. Each circuit card plugged into a slot in the front of the array has a redundant “paired” circuit card plugged into the back of the array. The path of the bullet through the array penetrated all circuit cards plugged into the front of the array. None of the circuit cards in the back of the array were physically impacted.
